Non-Destructive Testing of Composites by Ultrasound, Local Defect Resonance and Thermography [†]

Abstract: Different non-destructive testing techniques have been evaluated for detecting and assessing damage in carbon fiber reinforced plastics: (i) ultrasonic C-scan, (ii) local defect resonance of front/back surface and (iii) lock-in infrared thermography in reflection. Both artificial defects (flat bottom holes and inserts) and impact damage (barely visible impact damage) have been considered. The ultrasonic C-scans in reflection shows good performance in detecting the defects and in assessing actual defect parameters (e.g. size and depth), but it requires long scanning procedures and water coupling. The local defect resonance technique shows acceptable defect detectability, but has difficulty in extracting actual defect parameters without a priori knowledge. The thermographic inspection is by far the fastest technique, and shows good detectability of shallow defects (depth < 2 mm). Lateral sizing of shallow damage is also possible. The inspection of deeper defects (depth > 3-4 mm) in reflection is problematic and requires advanced post-processing approaches in order to improve th

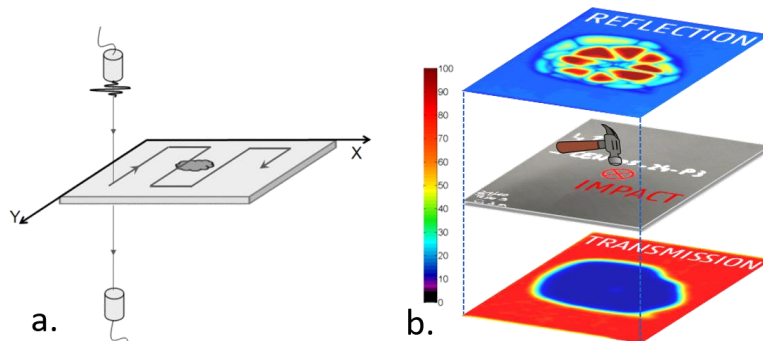
Figure 1: (a) Principle of C-scan and (b) ultrasonic C-scan in reflection (top) and transmission (bottom) for an impacted $[45/0/-45/90]_{3s}$ CFRP (middle) with impact energy 18.5 J. The color scale indicates the amplitude level.

The ultrasonic C-scan is perhaps the most widespread NDT technique [2]. In this technique, the surface of an immersed sample is scanned (see Figure 1), and a projection of the reflected and/or transmitted ultrasound is analyzed. Hence, it is a volumetric inspection method. The transmission C-scan leads to an integrated view of the damage zone, while the reflection C-scan provides details on the depth distribution of the damage zone (see Figure 1b). Typical frequencies are in the low MHz range (1–10 MHz) for composite materials. Lowering the frequency leads to poor spatial resolution as depth profiling is directly related to the ultrasonic wavelength. Increasing the frequency leads to excessive attenuation of the ultrasonic signal in composite materials due to high damping properties of the polymer matrix and scattering at fiber bundles and porosities.

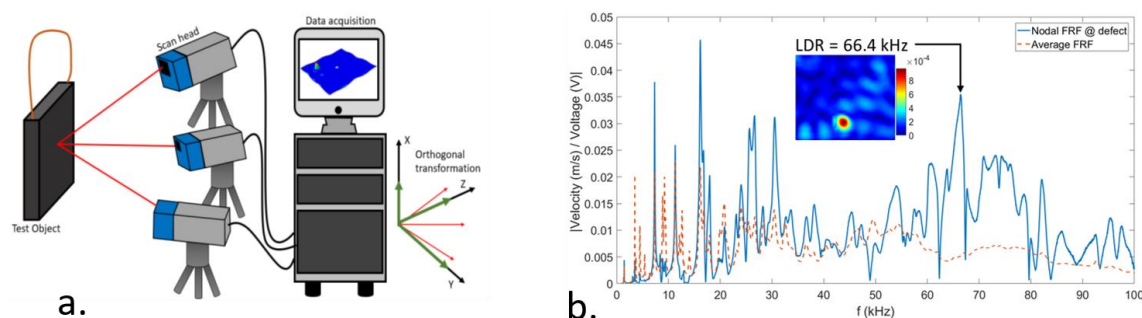
Figure 2: (a) Principle of 3D scanning laser Doppler vibrometry and (b) FRF of a [45/0/-45/90]_{3s} CFRP sample with a flat bottom hole (diameter of 10 mm).

Local defect resonance (LDR) has already been described in the early 1990s [9], though it is only recently that the technique has been explored extensively through the work of Solodov [5, 10]. Instead of classical vibration testing of components at low frequencies, the LDR technique rather employs elevated frequencies. Considering that a defective area has a locally different stiffness and/or mass, it will behave as a local resonator at specific elevated frequencies. The vibrational surface response can then be measured with scanning laser Doppler vibrometry (see Figure 2a). Hence, it is not a volumetric method, but rather a surface inspection method. In various research papers, the potential of the LDR technique has been demonstrated for a range of defects [5, 6, 10–13]. Recently, the LDR phenomenon has also been extended towards in-plane resonances, and it was shown that the concept of in-plane LDR is advantageous for detecting specific defect types [14]. Though, a current difficulty with the LDR technique concerns the fact that it is often not easy to actually identify the LDR response and the LDR frequency in measurement data. This is demonstrated in Figure 2b which displays the frequency response function (FRF) for a $[45/0/-45/90]_{3s}$ CFRP with a flat bottom hole (FBH). The orange curve is the average FRF of the CFRP, while the blue curve represents the nodal FRF at the FBH's location. This figure indicates the difficulty to distinguish between global mode shapes and LDR behavior by analysis of the average FRF, or even the nodal FRF in the defected zone. However, by careful manual inspection of the operational deflection shapes (ODS) over the full frequency range, a clear LDR of the FBH was found at 66.4 kHz. Our current research is focused towards automated identification of LDR features in a set of FRFs, and will be presented at the EWSHM 2018

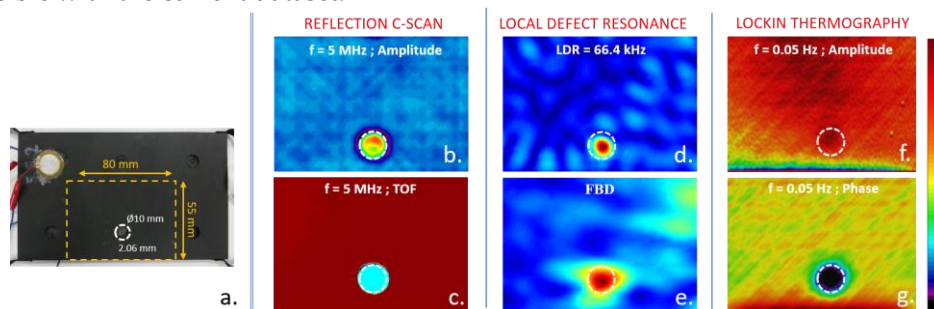
Figure 3: Results for CFRP_{FBH} : (a) photograph of inspected area. Ultrasonic C-scan at 5 MHz: (b) reflected amplitude and (c) TOF. Vibrational testing: (d) LDR at 66.4 kHz and (e) frequency band data FBD over 50-100 kHz. Lock-in thermography at 0.05 Hz: (f) amplitude and (g) phase image.

The inspection results for the CFRP_{FBH} sample are shown in Figure 3. The different inspections have been performed from the blind side of the FBH.

The ultrasonic C-scan in reflection (see Figure 3b-c) gives good estimation of the defect's lateral characteristics. Additional analysis of the TOF signal gives a depth estimation of 1.95 mm (versus 2.06 mm measured).

The results for the LDR are shown in Figure 3d-e. The LDR frequency was determined at 64.4 kHz, and the defect shape is easily recognizable (see Figure 3d) but is underestimated. This could have been expected as the defect can be perceived as a clamped sub-component. Hence, the outer part of the defect has reduced vibrational mobility compared to the inner part of the defect. The depth of the defect can be estimated on the basis of a simplified analytical solution [6], but only on the condition that defect geometry, defect size and material parameters (density, anisotropic stiffness tensor) are known a priori. Unfortunately such a priori information is often unknown, even for this model sample. The frequency band data FBD over 50-100 kHz is shown in Figure 3e and also clearly reveals the location of defect (without the need to search for a LDR characteristic in the FRF data).

The lock-in thermography result in reflection is shown in Figure 3d. Four sinusoidal cycles with frequency of 0.05 Hz have been employed. The frequency of 0.05 Hz was proven to be the most sensitive for the particular depth of the FBH. The amplitude image give little to no quantitative information (at least without further post-processing). While the phase image succeeds in providing an image from which lateral defect parameters can be extracted. Extraction of the defect depth is not possible with the current dataset.

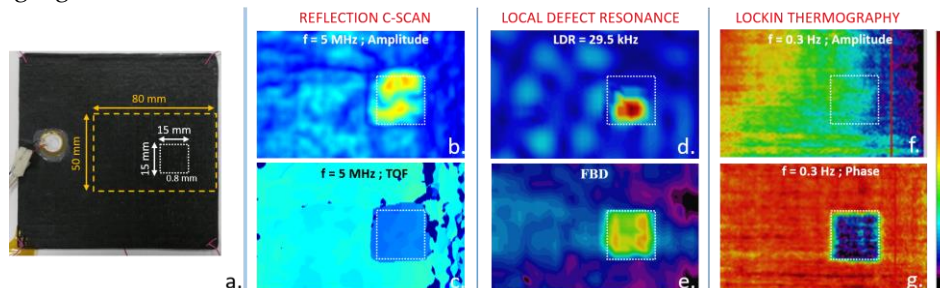
Figure 4: Results for CFRP_{INSERT}: (a) photograph of inspected area. Ultrasonic C-scan at 5 MHz: (b) reflected amplitude and (c) TOF. Vibrational testing: (d) LDR at 29.5 kHz and (e) frequency band data FBD over 5–100 kHz. Lock-in thermography at 0.3 Hz: (f) amplitude and (g) phase image.

Figure 4 presents the NDT results for the CFRP_{INSERT} sample. For this case, the three NDT techniques provide indicative results on the lateral defect parameters.

The ultrasonic C-scan nicely indicates the lateral dimensions of the defect. Though, the TOF image is of poor quality and makes it difficult to estimate the depth of the defect. This is due to the small ratio of defect-depth-to-wavelength, which makes accurate extraction of TOF troublesome, as well as to the significantly lower quality of the CFRP_{FBH} sample (when compared to the other CFRP samples). Hence, the ultrasonic signal did not show good reflection on the ETFE insert, and was therefore difficult to capture in a steady and uniform way.

For the LDR at frequency of 29.5 kHz, we got a significant underestimation of lateral defect size (see Figure 4d). On the other hand, it is interesting to note that the frequency band data FBD over 5–100 kHz (Figure 4e) gives a good estimation of actual lateral defect size, without the need to search for LDR phenomena in the average or nodal FRF data.

The IRT results have been obtained at a lock-in frequency of 0.3 Hz as this provided best results for an inspection depth of 0.8 mm. It is clear that a good contrast is obtained for the phase image, giving a good estimation of lateral defect size.

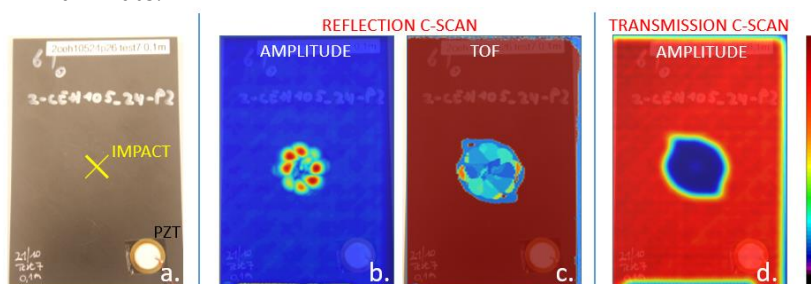
Figure 5: (a) photograph of CFRP_{BVID}, (b) amplitude reflection C-scan, (c) TOF reflection C-scan and (d) amplitude transmission C-scan.

The damage type for the CFRP_{BVID} sample (see Figure 5a) is far more complex compared to the previous two cases, and should be conceived as a combination of different defects (e.g. delamination, cracks ...) distributed through depth.

This is nicely indicated by the ultrasonic C-scan in reflection (see Figure 5 b–c). The amplitude recording indicates multiple defects at the impact location, while the TOF indicates that these defects are distributed through thickness (blue = shallow defect, red = deep defect). Analysis of the damage zone indicates that the impactor has induced a delamination cone through thickness, which extends like a double helix through the sample (and thus clearly relates to the quasi-isotropic lay-up of the [45/0/-45/90]_{3s} CFRP). Note that the upper delaminations have a shadowing effect on the lower delaminations. In reality, the deeper delaminations also extend until the impact location. The C-scan in transmission (Figure 5d) provides an integrated view of the delamination cone. Although the impact energy was only 6.3 J, the C-scan results indicate that considerable damage was induced in the CFRP laminate.

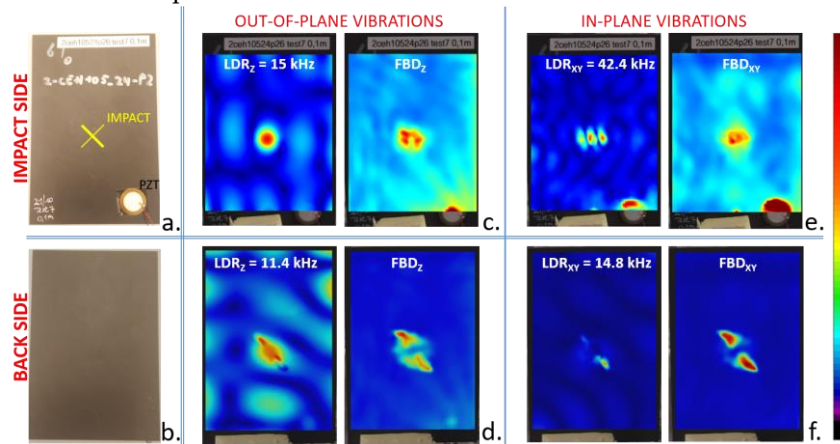
Figure 6: Results of impact side (top row) and backside (bottom row) of CFRP_{BVID}: (a-b) photograph of sample, (c-d) out-of-plane LDR_z and frequency band data FBD_z over 2-100 kHz and (e-f) in-plane LDR_{xy} and frequency band data FBD_{xy} over 2-100 kHz.

The LDR response for the CFRP_{BVID} sample is displayed in Figure 6. In this case, it is difficult to identify 1 single LDR frequency, exactly because of the complexity of the damage zone. The fact that LDR is not a volumetric inspection method combined with the complex 3D damage zone (see Figure 5b–c) is not favourable for clear interpretation. Therefore, the CFRP_{BVID} has been scanned at both the impact side and the backside, see Figure 6 (top row) and Figure 6 (bottom row) respectively. Additionally, the vibrational analysis was further extended towards in-plane LDR phenomena in order to get further insight on the structure of the complex 3D damage zone [14]. For clarity, the

classical out-of-plane LDR is indicated by LDR_z , while in-plane LDR is indicated by LDR_{xy} . By careful manual peak-picking, LDR_z and LDR_{xy} modes have been identified. The results indicate that the extension towards in-plane vibrational characteristics give access to other defect parameters. As there are many higher-order LDR_z and LDR_{xy} modes identified in the considered bandwidth, we opted to only show the fundamental LDR's together with a representation of the out-of-plane frequency band data FBD_z and in-plane frequency band data FBD_{xy} over the total frequency band of 2-100 kHz. The increased surface velocities of the many high order LDRs in the total frequency band should be hinted in the FBD_z and FBD_{xy} , and thus should give a representation of zones with reduced stiffness (i.e. damaged zones). The results are displayed in Figure 6c-f, and qualitatively match the ultrasonic C-scans (see Figure 5). It is clear that this set of results provides useful information, but it is equally clear that further research is needed in order to interpret these results, and eventually to link them to quantitative defect parameters.

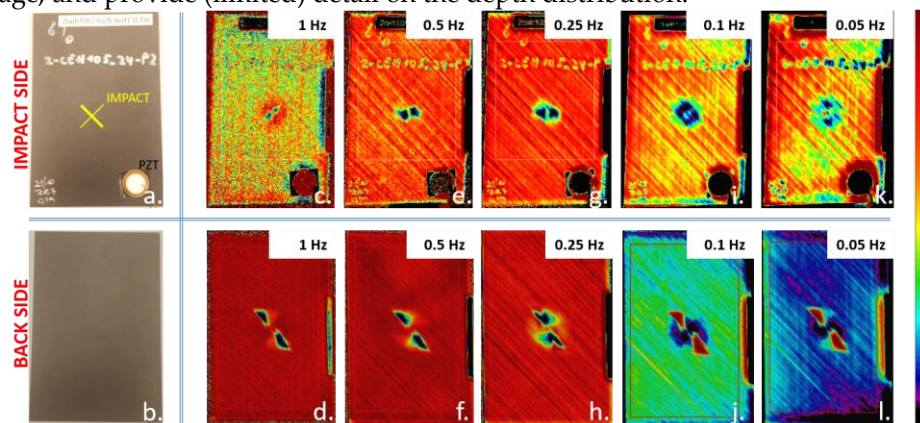
Figure 7: IRT in reflection of impact side (top row) and backside (bottom row) of CFRP_{BVID}: (a-b) photograph; phase images at (c-d) 1 Hz, (e-f) 0.5 Hz, (g-h) 0.25 Hz, (i-j) 0.1 Hz and (k-l) 0.05 Hz.

Finally, the lock-in thermography has been applied on the CFRP_{BVID} sample. Considering that the delamination cone is distributed through thickness, various lock-in frequencies have been selected. As the CFRP_{BVID} sample has a high thickness, one should select very low frequency to probe the complete sample in reflection mode (under the assumption that the SNR is still sufficient). Such low frequencies would result in unacceptable heating ($T > 100^\circ\text{C}$) of the front surface, and subsequent degradation of the thermoset matrix in the CFRP_{BVID}. Instead, it was opted to perform IRT in reflection from both the impact side and the backside of the CFRP_{BVID} sample. The IRT results are displayed in Figure 7, and cover the frequencies 1 Hz, 0.5 Hz, 0.25 Hz, 0.1 Hz and 0.05 Hz. The difference between inspection from impact side and backside is clear. The results globally indicate the extent of the damage, and provide (limited) detail on the depth distribution.
